## **Schedule of Work to External Elevations.**

Darnhall Village Hall, Hall Lane, Winsford, CW7 4HA.

August 2024

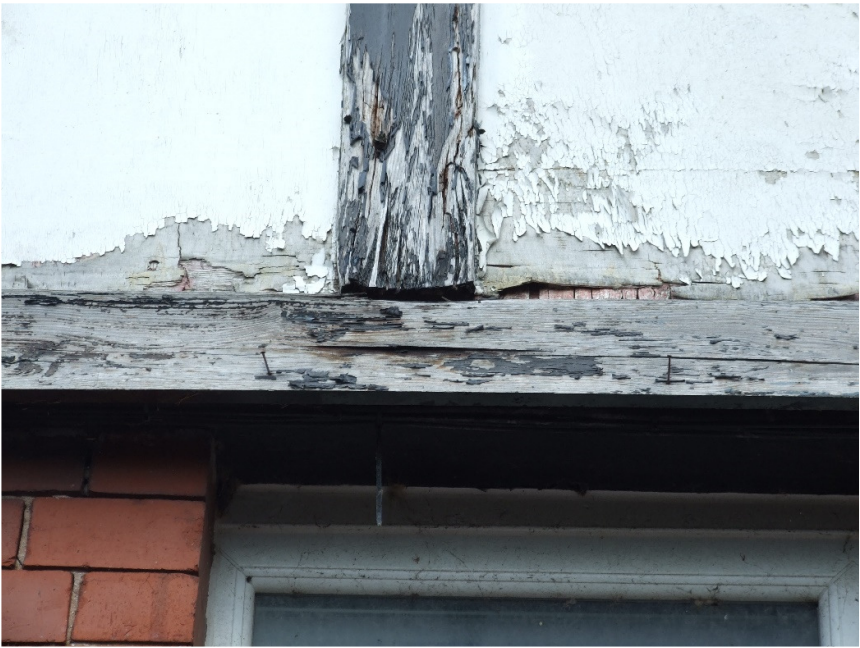
| Photo No | Photograph Description | Photograph |
|---|---|---|
| 9. | <b>MAIN ISSUES<br/>ALL<br/>ELEVATIONS</b><br><br><b>TUDOR EFFECT<br/>BOARDS</b> | |

| Photo No | Photograph Description | Photograph |
|---|---|---|
| 10. | Tudor effect<br>boarding.<br>V Poor | <p>Tudorised boards to main gable to front elevation and smaller gables to each elevation are rotted and require replacement ply boards and timber planks, to be painted following insertion.</p> <p>Cameras and lights are fitted to gables these are to be reinstated unless specifically requested not to.</p> |

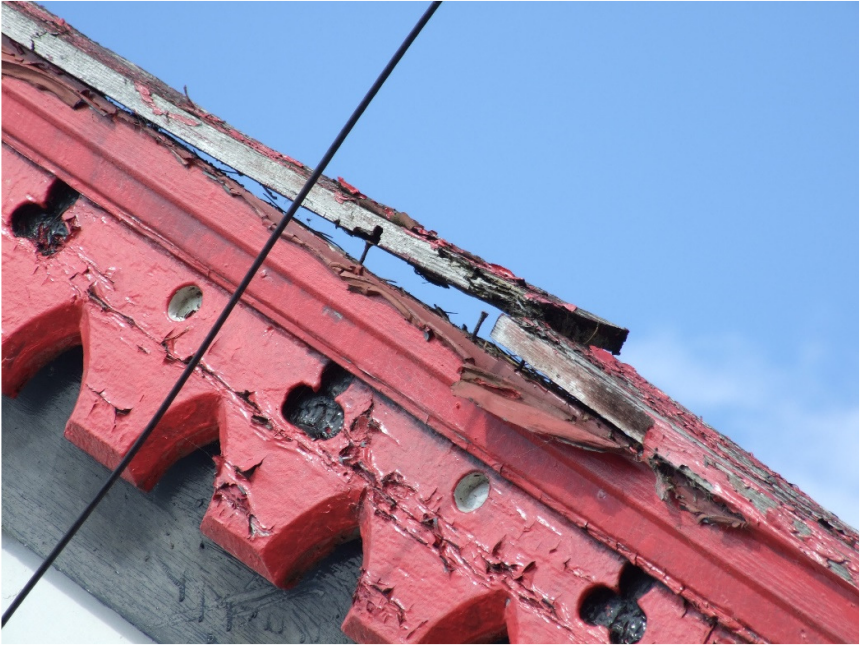
| Photo No | Photograph Description | Photograph |
|---|---|---|
| 11. | <b>BARGE<br/>BOARDS AND<br/>VERGES</b> | |

| Photo No | Photograph Description | Photograph |
|---|---|---|
| 13. | Barge boards and verges<br><br>V Poor | Timber detailed barge boards are rotten in places and with small detachment, timber trims to verge also rotten and peeling paint. Trims to roof verge to be removed and replaced with plastic trim 'L' shaped to cover roof and part barge boards. Barge boards are to be retained where possible or resecured, cleaned of all loose paint, new timber spliced in if required and overboarded in UPVC fascia, size to suit to cover all of barge board. |

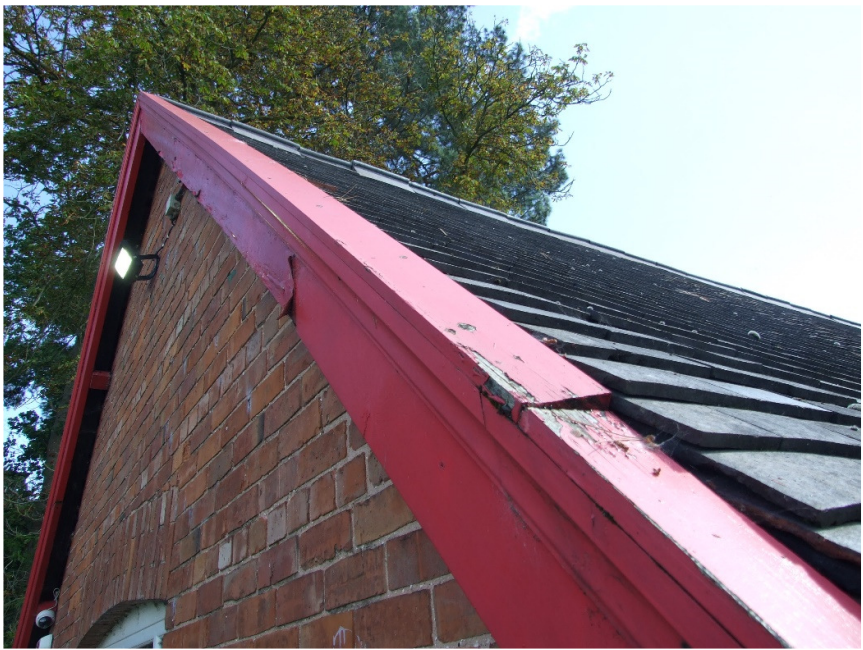
| Photo No | Photograph Description | Photograph |
|---|---|---|
| 12. | Rear barge board to gable has detached and only held in place by restraint plate, barge requires resecuring prior to over boarding. | |

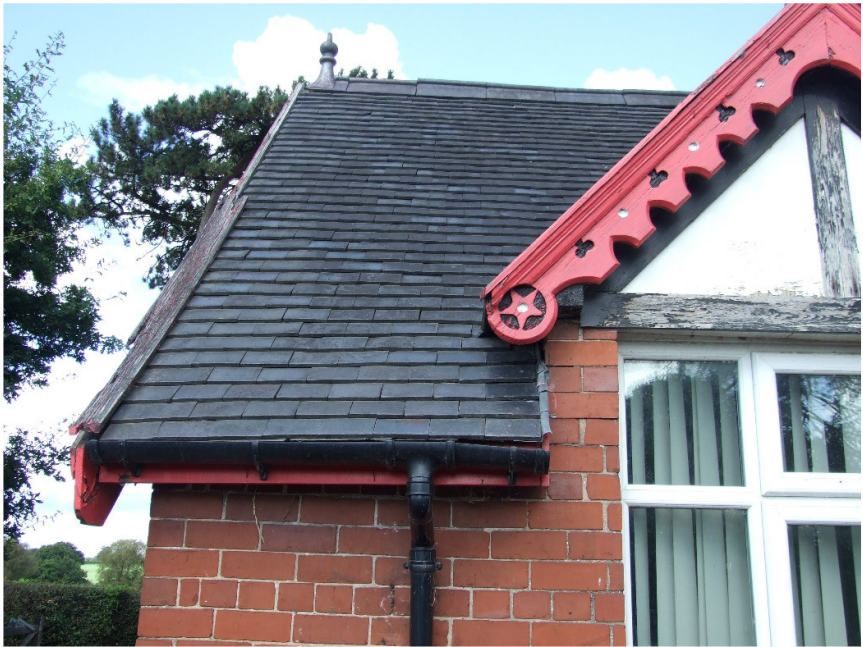
| Photo No | Photograph Description | Photograph |
|---|---|---|
| 14. | <b>GUTTERS</b><br>Gutters fall wrong way<br><br>Poor | |

| Photo No | Photograph Description | Photograph |
|---|---|---|
| 19. | Poor | Gutters and RWP's to be removed and set aside for refitting to correct falls after fascia's upgraded. All to be cleaned. Additional brackets and guttering may need to be supplied. Gullies to right elevation to be leveled and shoes provided to RWP's. Following re fitting gutter guards to be supplied and fitted to right hand elevation gutters. |

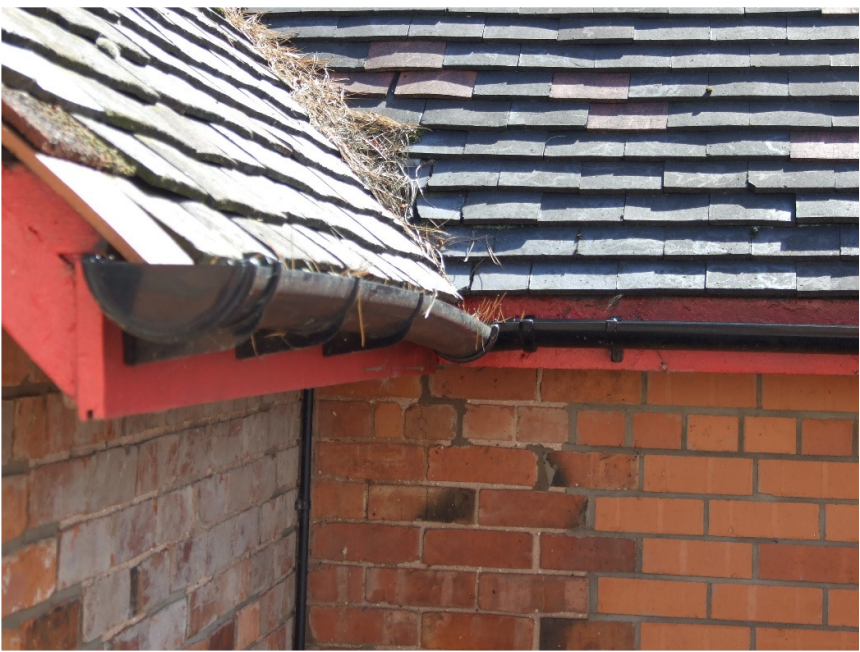
| Photo No | Photograph Description | Photograph |
|---|---|---|
| 15. | Gutters fall wrong way | |

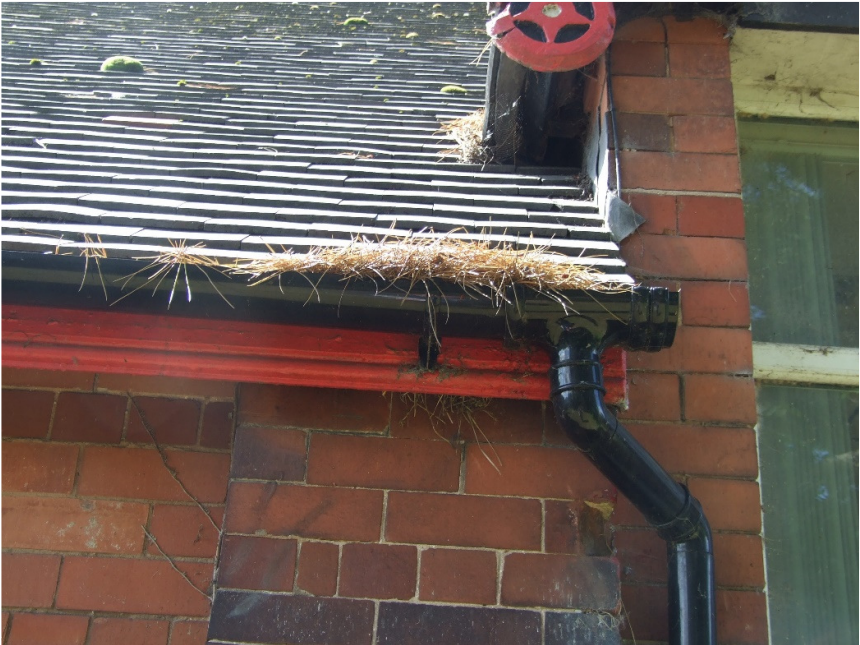
| Photo No | Photograph Description | Photograph |
|---|---|---|
| 16. | Gutters full of pine needles to right elevation | |

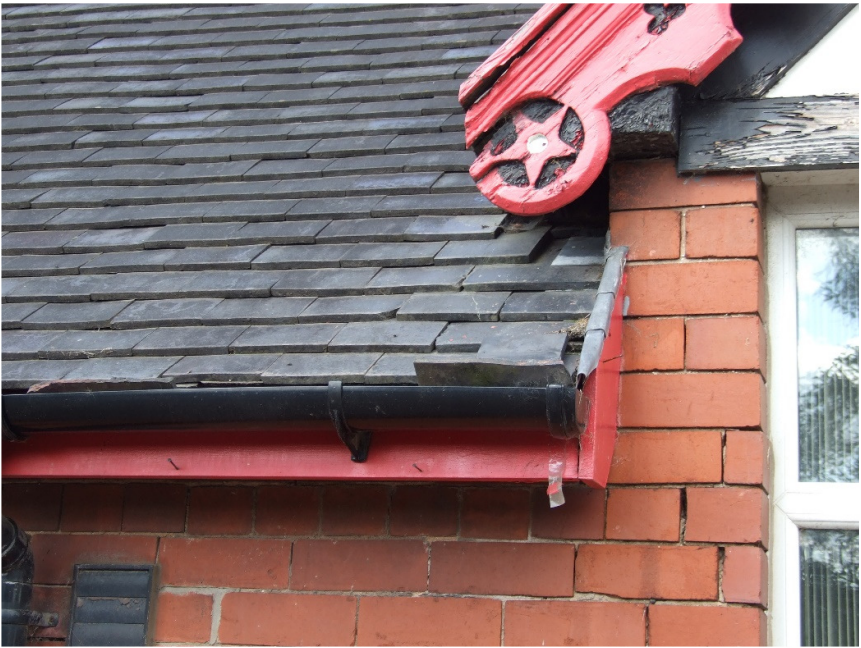
| Photo No | Photograph Description | Photograph |
|---|---|---|
| 20. | <p><b>ROOF GENERAL</b></p> <p>Slipped slates to front elevation.</p> <p>Poor</p> | |

| Photo No | Photograph Description | Photograph |
|---|---|---|
| 31. | Poor | Roof to be full overhauled with any cracked or mismatched tiles to be replaced with reclaimed clay files, valleys to be cleaned and checked and any tiles replaced if necessary. |

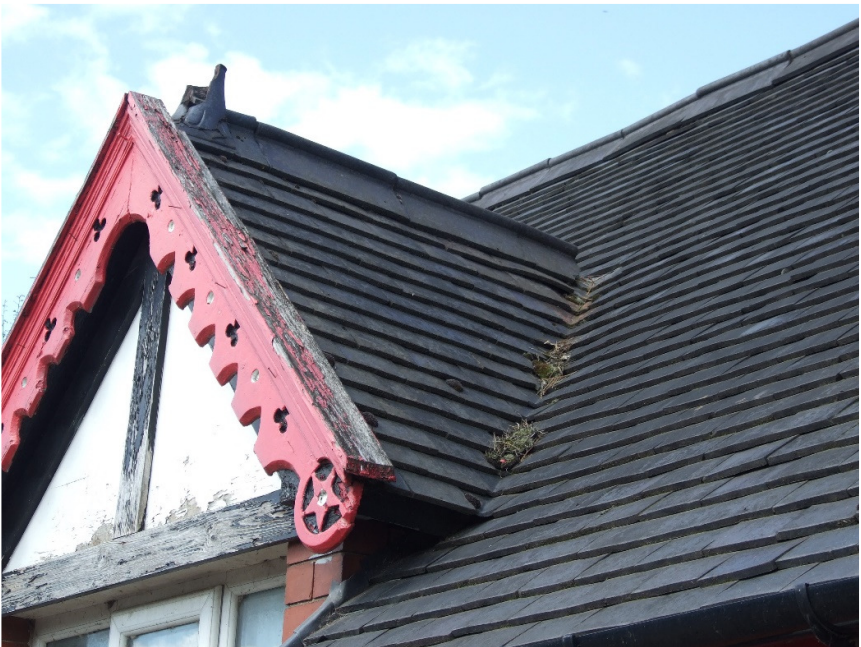
| Photo No | Photograph Description | Photograph |
|---|---|---|
| 21. | <p>All valleys to be cleaned of debris and checked for broken tiles.</p> | |

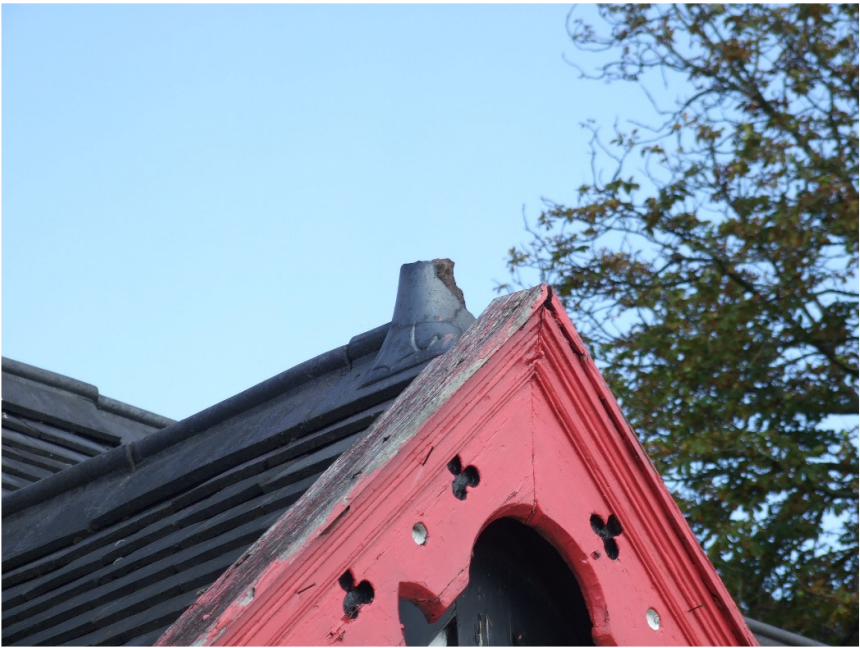
| Photo No | Photograph Description | Photograph |
|---|---|---|
| 22. | Finials to be replaced or repaired, possible lead caps fitted to prevent any water ingress. | |

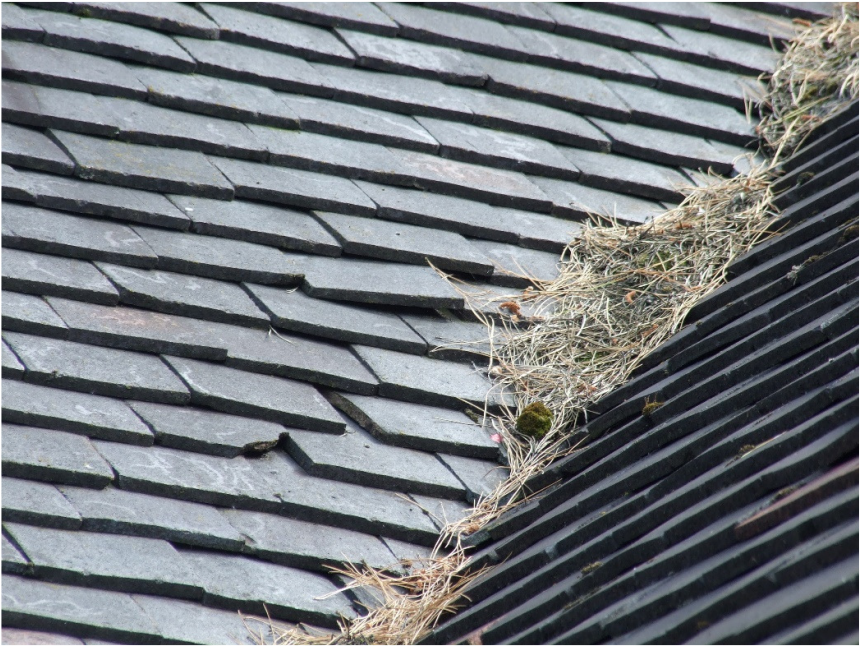
| Photo No | Photograph Description | Photograph |
|---|---|---|
| 23. | All valleys to be cleaned of debris and checked for broken tiles. | |

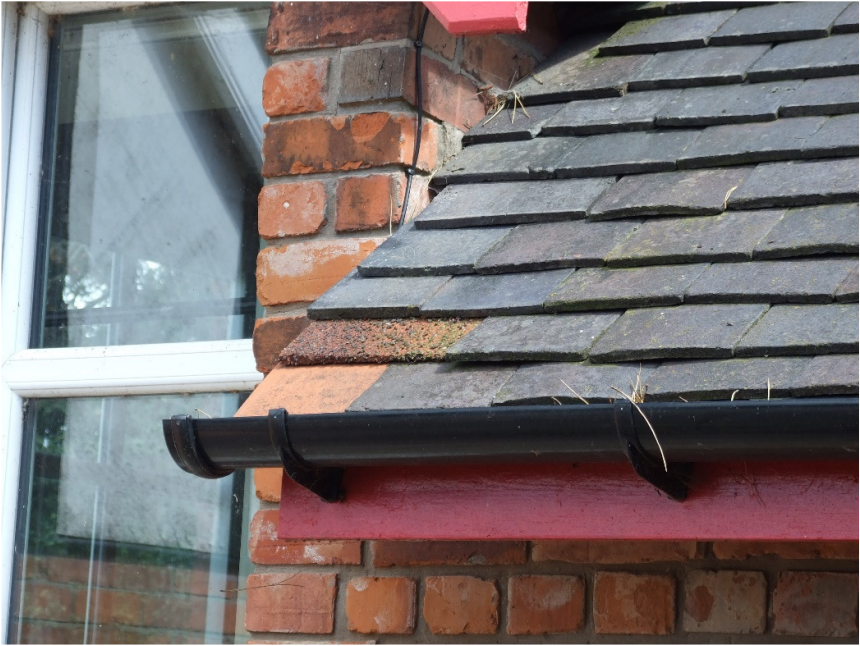
| Photo No | Photograph Description | Photograph |
|---|---|---|
| 24. | Right elevation, miss matched previously replaced tiles to be replaced for reclaimed clay. | A close-up photograph of the roofline on the right elevation. It shows a section of red brickwork next to a window with a white frame. The roof tiles are dark grey or black, and a black gutter is visible. A red horizontal band is painted on the brickwork below the gutter. |

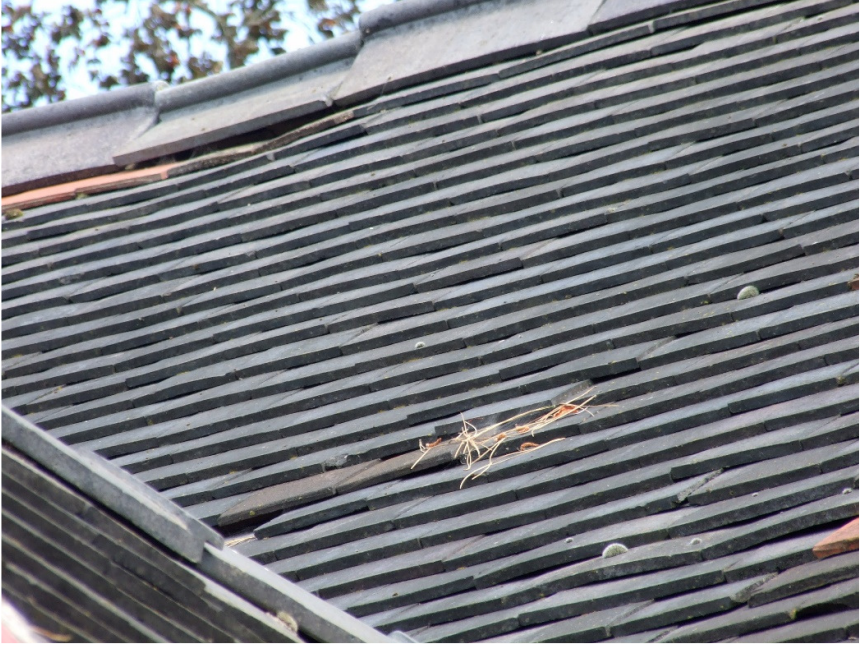
| Photo No | Photograph Description | Photograph |
|---|---|---|
| 25. | Left elevation left side ridge and tiles to be checked and reset if required. | A close-up photograph of the roofline on the left elevation, focusing on the ridge and tiles. The tiles are dark grey or black, and the ridge is made of wooden battens. Some debris is visible on the tiles. |

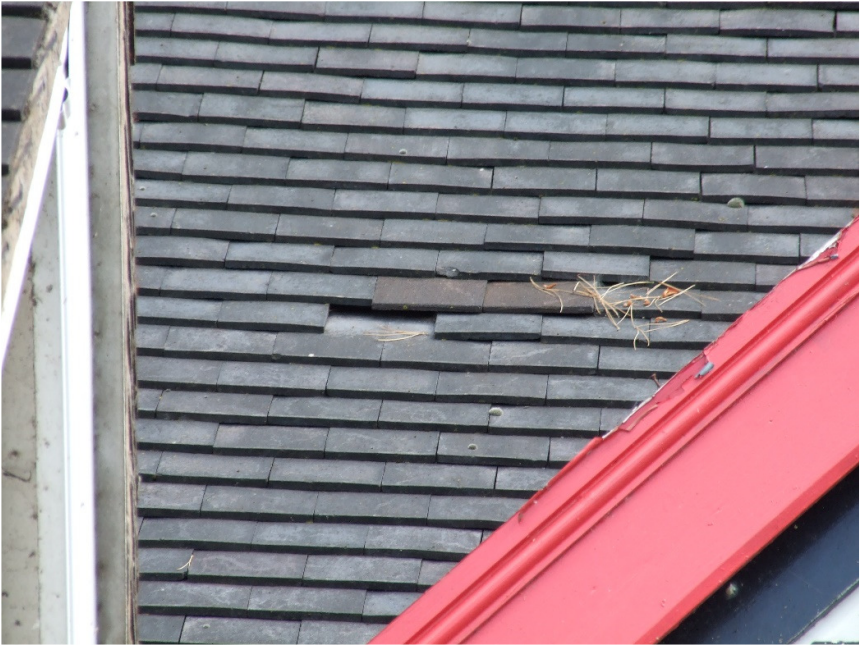
| Photo No | Photograph Description | Photograph |
|---|---|---|
| 26. | Typical defects are cracked tiles, to be replaced with reclaimed clay tiles. | |

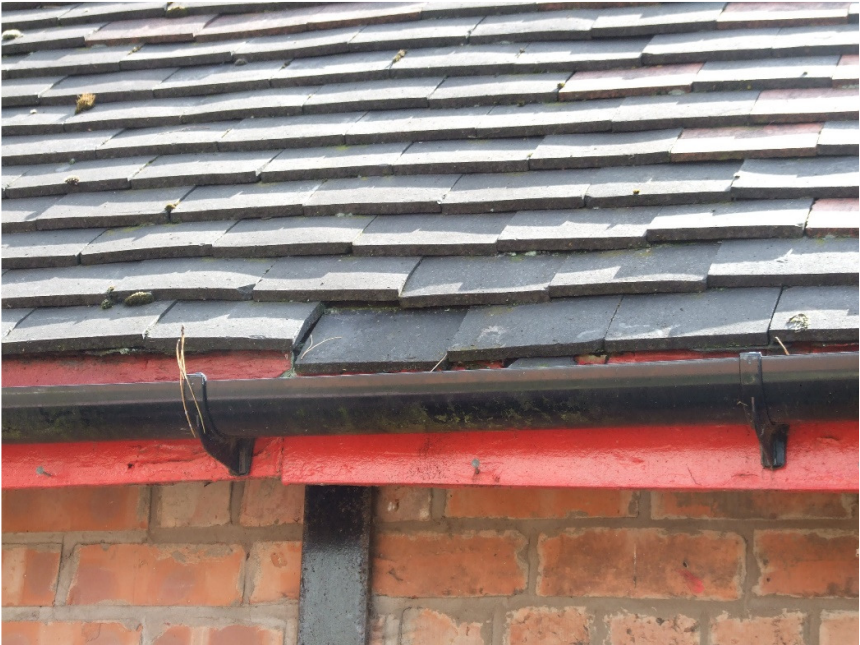
| Photo No | Photograph Description | Photograph |
|---|---|---|
| 27. | Typical defects are cracked tiles, to be replaced with reclaimed clay tiles. Battens to be checked at eaves line. | |

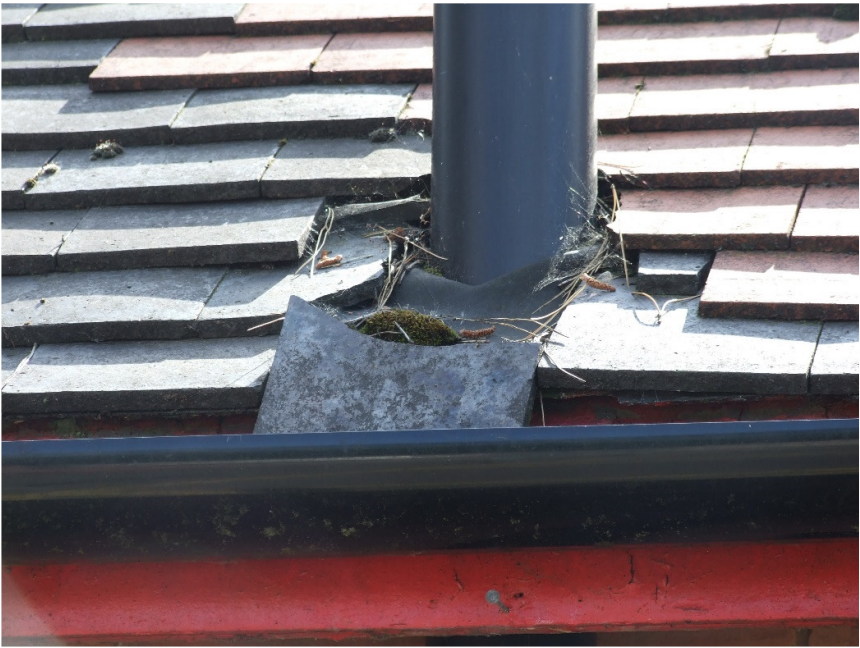
| Photo No | Photograph Description | Photograph |
|---|---|---|
| 28. | Typical defects are cracked tiles, to be replaced with reclaimed clay tiles. | |

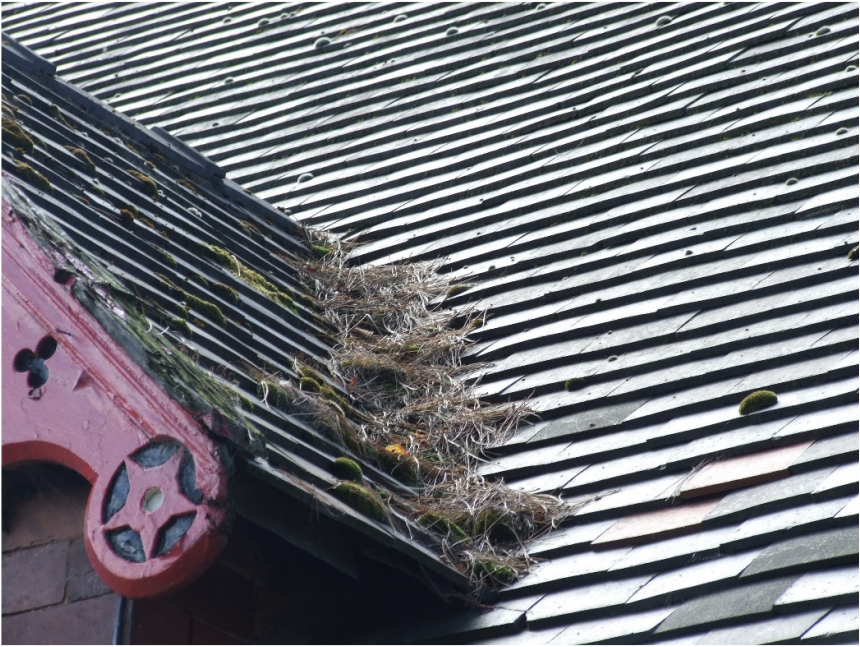
| Photo No | Photograph Description | Photograph |
|---|---|---|
| 29. | All valleys to be cleaned of debris and checked for broken tiles. | |

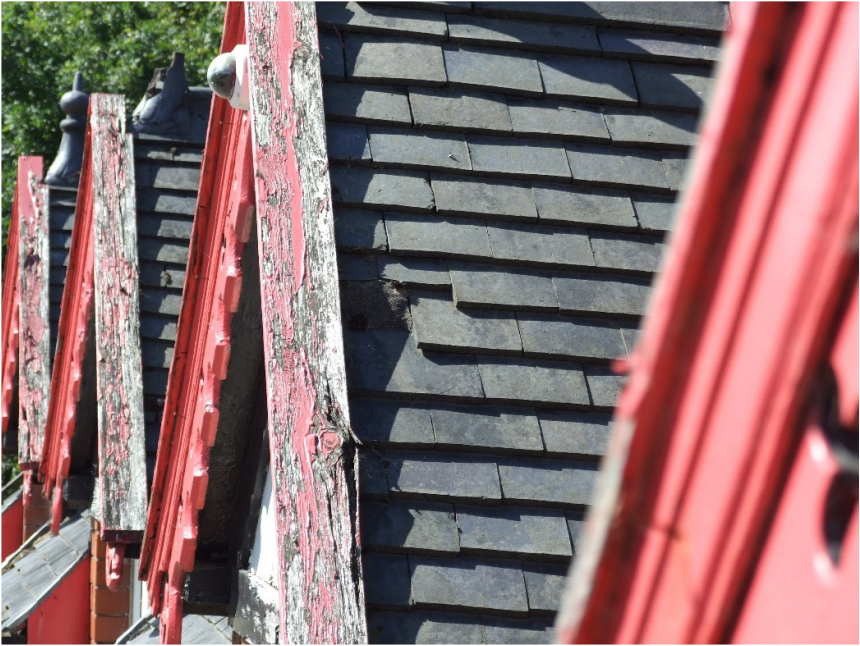
| Photo No | Photograph Description | Photograph |
|---|---|---|
| 30. | Typical defects are cracked tiles, to be replaced with reclaimed clay tiles. | |

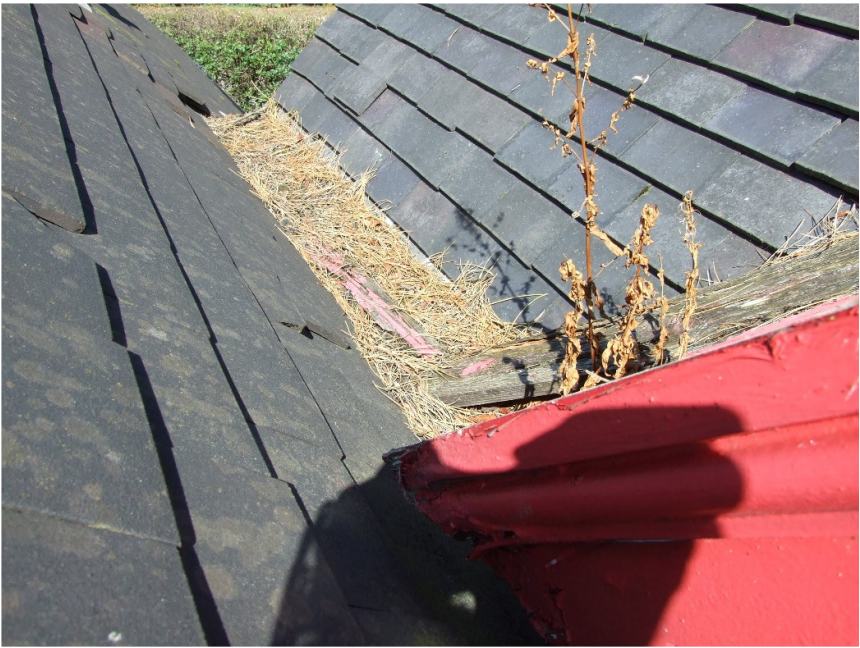
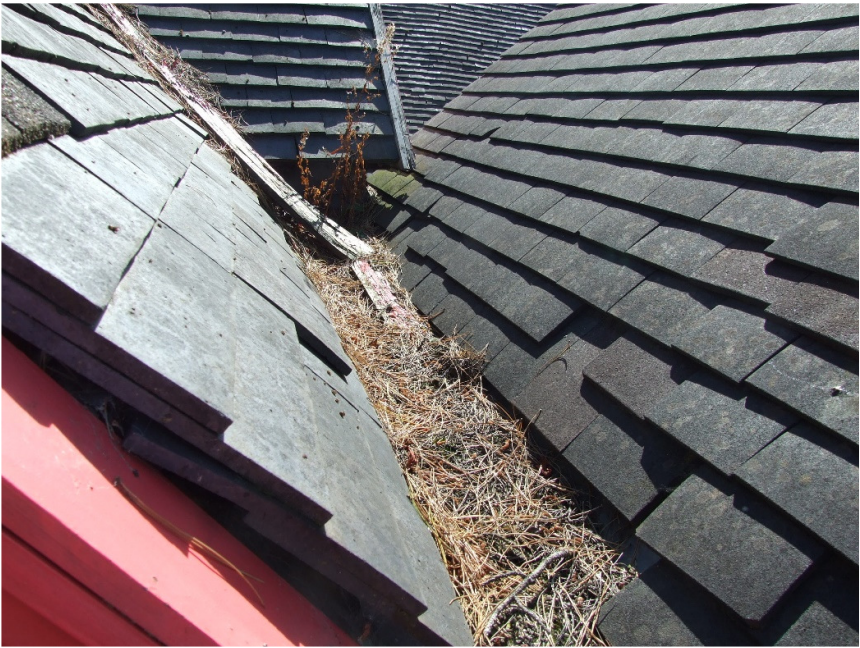
| Photo No | Photograph Description | Photograph |
|---|---|---|
| 32. | Valley at rear porch. | |

| Photo No | Photograph Description | Photograph |
|---|---|---|
| 33. | Valley at rear porch. | |

| Photo No | Photograph Description | Photograph |
|---|---|---|
| 34. | Poor | Valley to be cleaned of all debris and vegetation and checked for integrity and overpainted in fibre paint if required. |

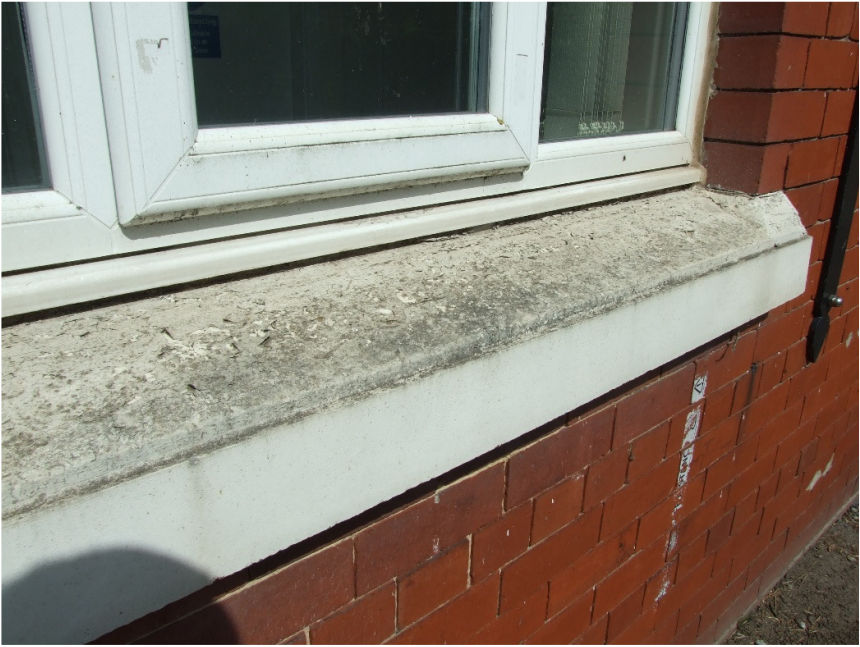
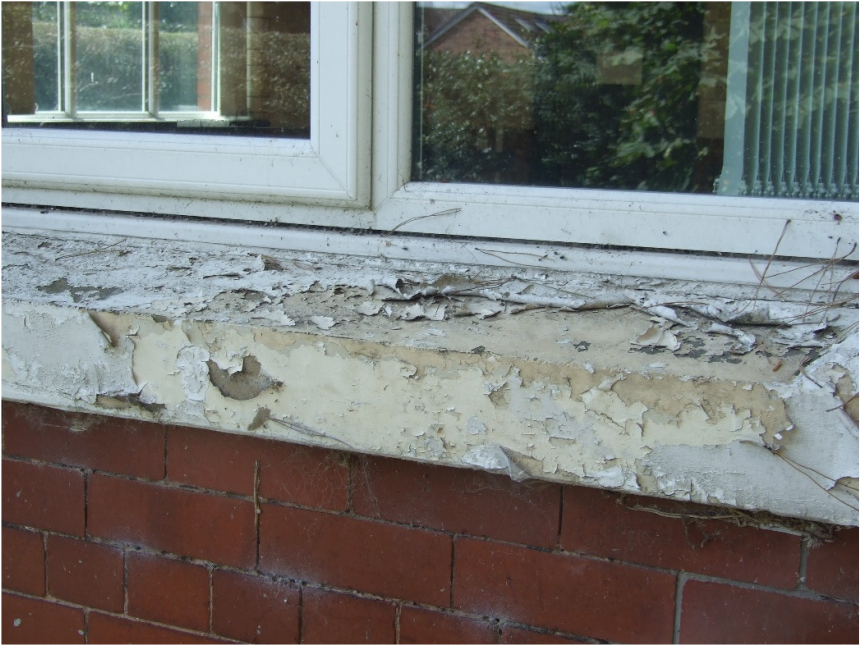
| Photo No | Photograph Description | Photograph |
|---|---|---|
| 35. | Window sills | |

| Photo No | Photograph Description | Photograph |
|---|---|---|
| 36. | Window sills | |

| Photo No | Photograph Description | Photograph |
|---|---|---|
| 37. | Poor | All stone sills to be sanded down and prepared to receive undercoat and two coats of satin external quality paint. |

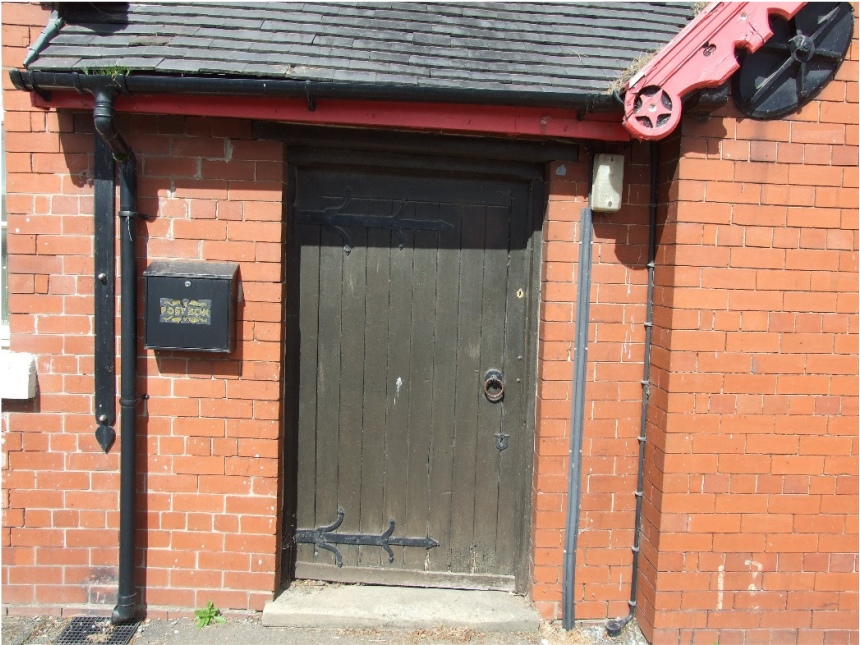
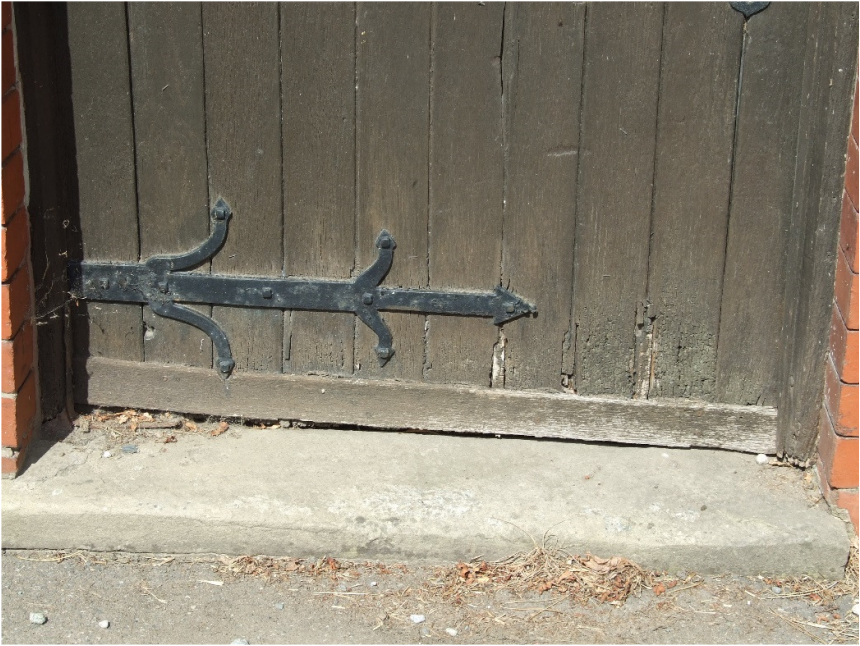
| Photo No | Photograph Description | Photograph |
|---|---|---|
| 38. | Original front door | |

| Photo No | Photograph Description | Photograph |
|---|---|---|
| 39. | Original front door | |

| Photo No | Photograph Description | Photograph |
|---|---|---|
| 40. | Poor | Door to be prepared and filled prior to undercoat and two coats of satin exterior paint. |

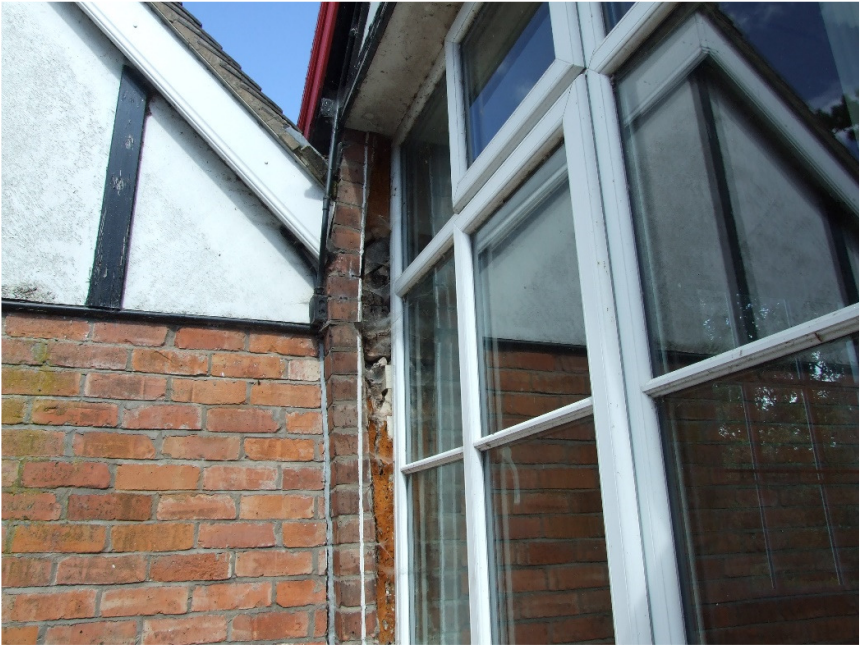
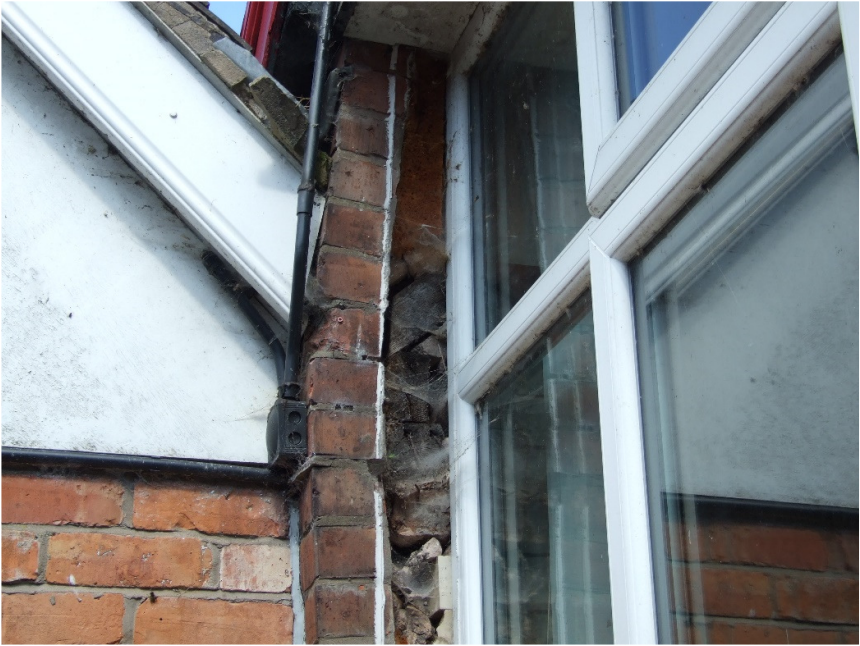
| Photo No | Photograph Description | Photograph |
|---|---|---|
| 41. | Movement at junction of porch and hall. | |

| Photo No | Photograph Description | Photograph |
|---|---|---|
| 42. | Movement at junction of porch and hall. | |

| Photo No | Photograph Description | Photograph |
|---|---|---|
| 43. | V Poor | UPVC trim to be provided over existing gap to prevent any water ingress. |

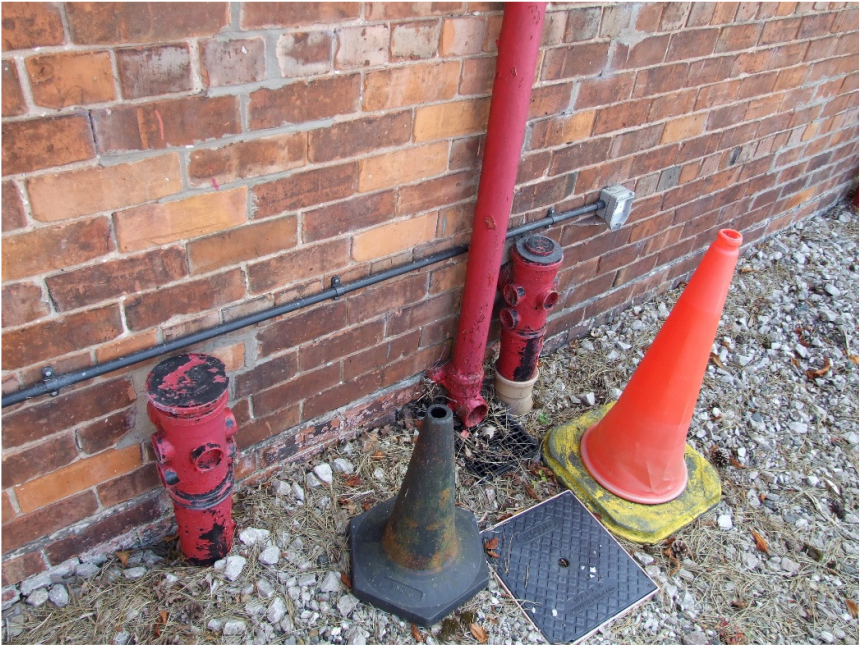
| Photo No | Photograph Description | Photograph |
|---|---|---|
| 44. | Retained Cast iron RWP to be changed to UPVC (Black).<br><br>Stub stacks to be prepared and painted black or replaced.<br><br>Poor | |

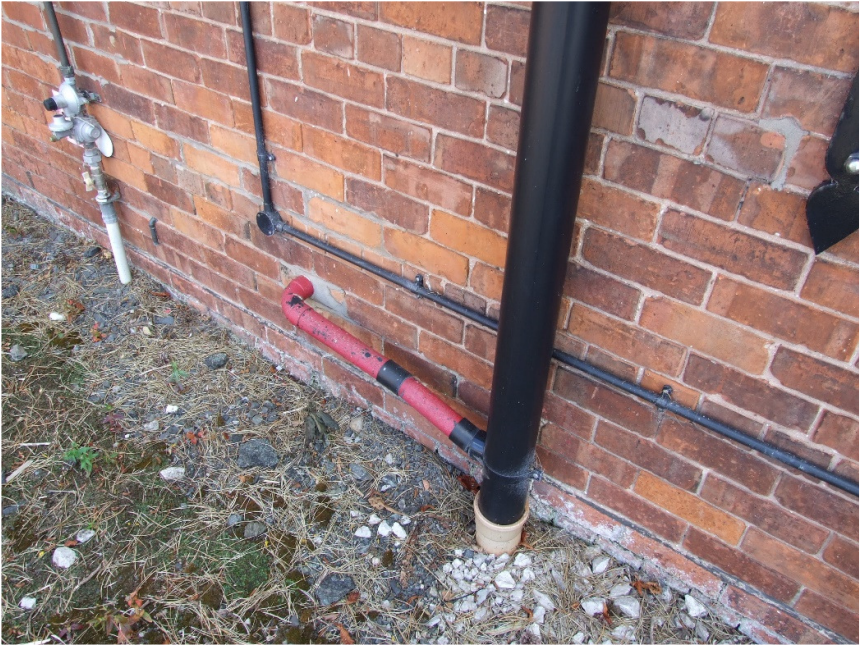
| Photo No | Photograph Description | Photograph |
|---|---|---|
| 45. | <p>Pipework to be changed to black or prepared and painted black.</p> <p>Poor</p> | |
